Manhole Inspection Summary

Manhole # S31S1_030MH

Insp Date: **2/18/08 9:33 AM**

Location Address: **3520 Spelman Road**

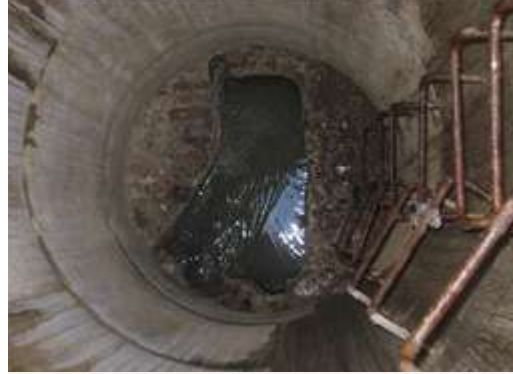
Top View

Infiltration: ☐ None ☐ Joint ☐ Cracks ☒ **Mortar** ☐ Roots ☐ Wall

Infiltration: ☐ None ☐ Joint ☐ Cracks ☐ Mortar ☐ Roots ☒ **Wall**
